Final Report

Space Environmental Effects on Thermal Control Coatings

Susan K. O'Brien
Senior Research Associate
and
Gary L. Workman Ph.D.
Principal Investigator

Materials Processing Laboratory Center for Automation & Robotics University of Alabama in Huntsville Huntsville, Alabama 35899

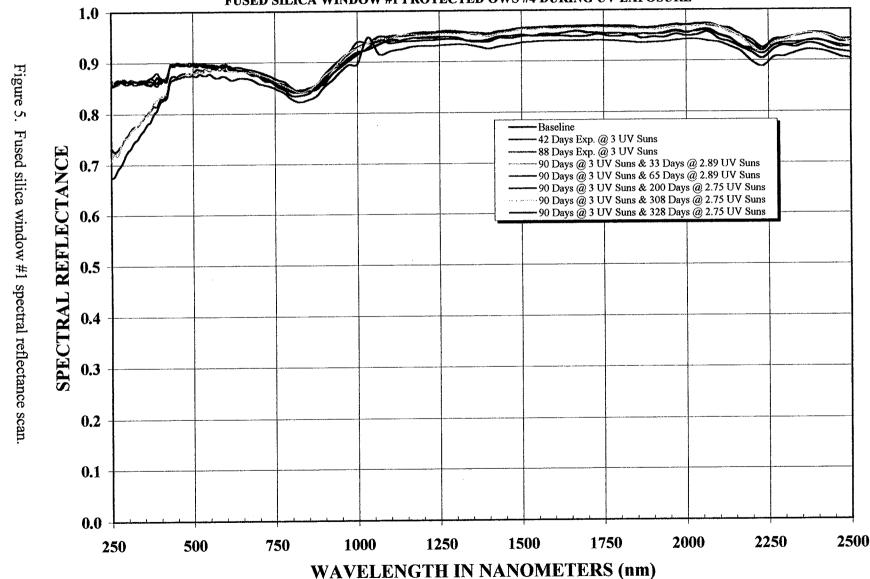
FUSED SILICA WINDOW #1 - LPSR DATA

BASELINE VS 418 DAYS OF UV EXPOSURE , ALPHA=0.104 BEFORE VS 0.127 AFTER EXPOSURE FUSED SILICA WINDOW #1 PROTECTED OWS #4 DURING UV EXPOSURE

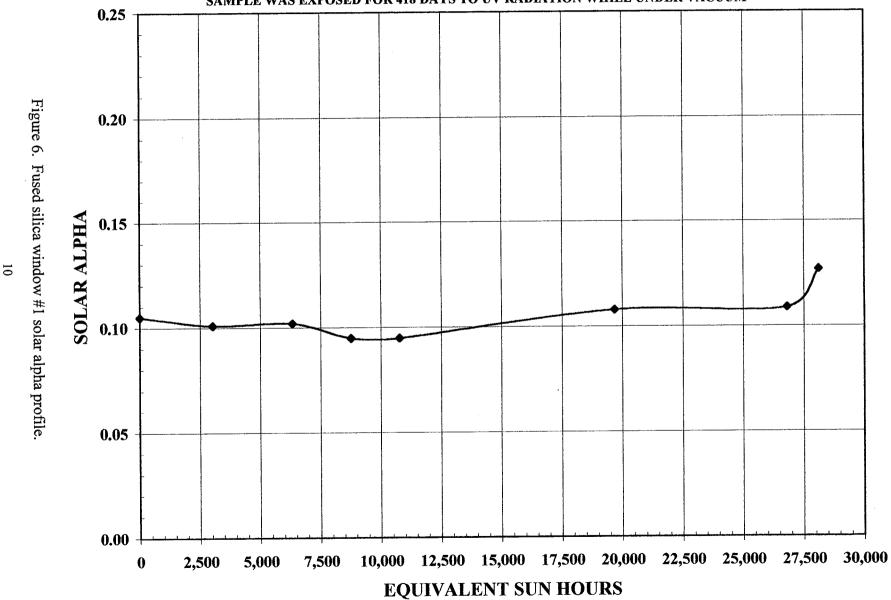
CHANGE IN SOLAR ALPHA FOR FUSED SILICA WINDOW #1

FUSED SILICA WINDOW #1 PROTECTED OWS #4 DURING UV EXPOSURE SAMPLE WAS EXPOSED FOR 418 DAYS TO UV RADIATION WHILE UNDER VACUUM

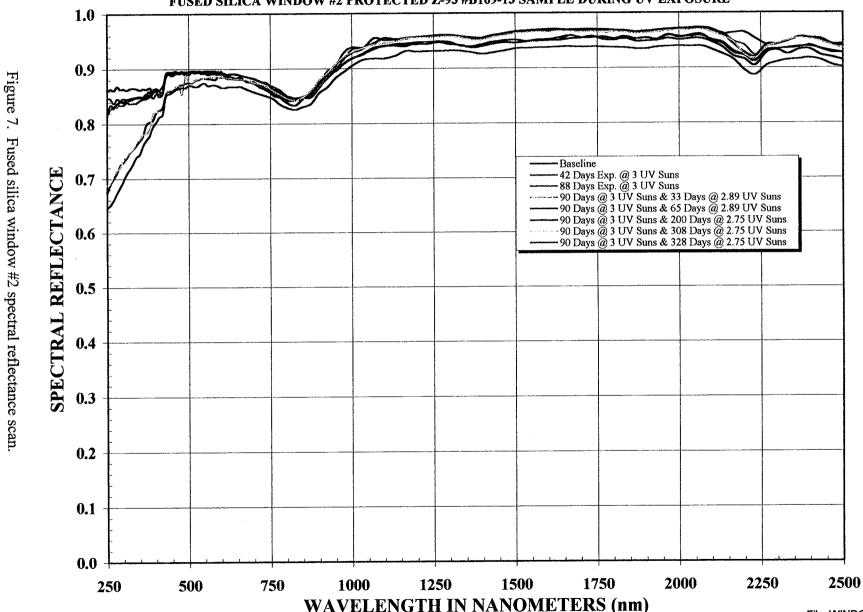
FUSED SILICA WINDOW #2 - LPSR DATA

BASELINE VS. 418 DAYS OF UV EXPOSURE, ALPHA=0.103 BEFORE AND 0.131 AFTER EXPOSURE FUSED SILICA WINDOW #2 PROTECTED Z-93 #B169-13 SAMPLE DURING UV EXPOSURE

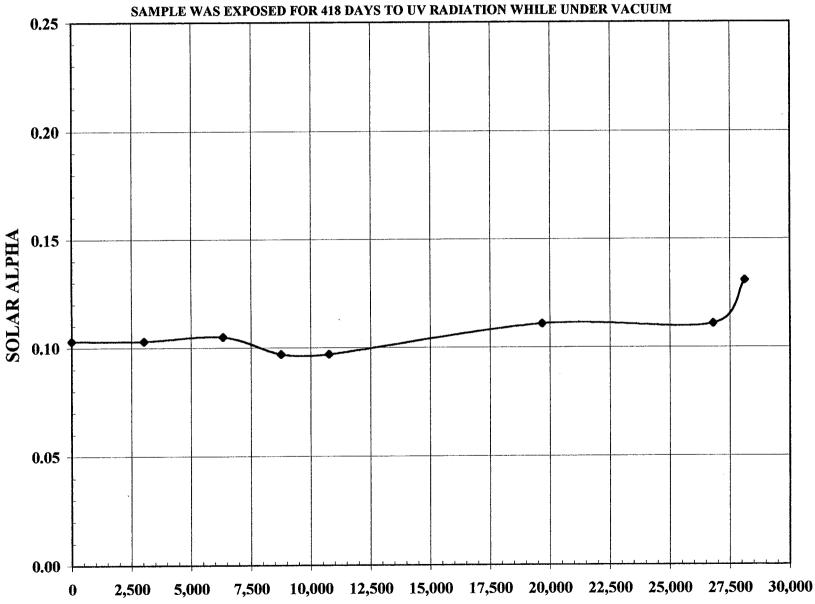
Figure 8. Fused silica window #2 solar alpha profile.

FUSED SILICA WINDOW #2 PROTECTED Z-93 B-169-13 SAMPLE DURING UV EXPOSURE

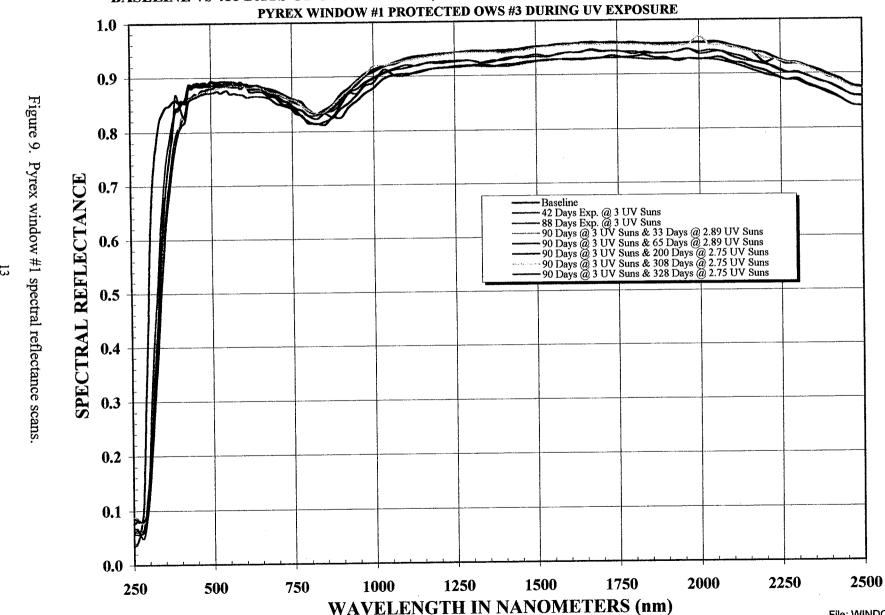
PYREX WINDOW #1 - LPSR DATA

BASELINE VS 418 DAYS OF UV EXPOSURE, ALPHA=0.137 BEFORE VS 0.161 AFTER EXPOSURE

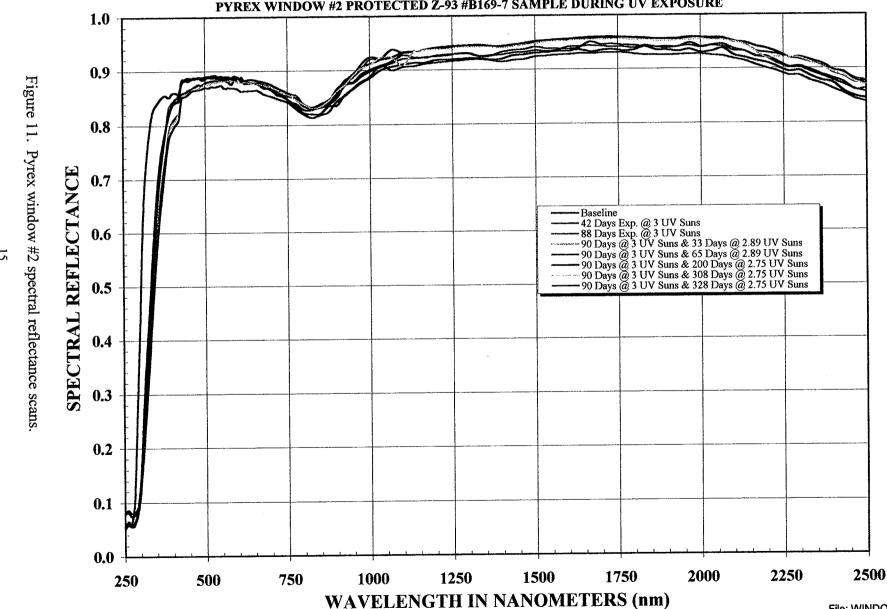
PYREX WINDOW #2 - LPSR DATA

BASELINE VS 418 DAYS OF UV EXPOSURE, ALPHA=0.133 VS 0.163 AFTER EXPOSURE PYREX WINDOW #2 PROTECTED Z-93 #B169-7 SAMPLE DURING UV EXPOSURE

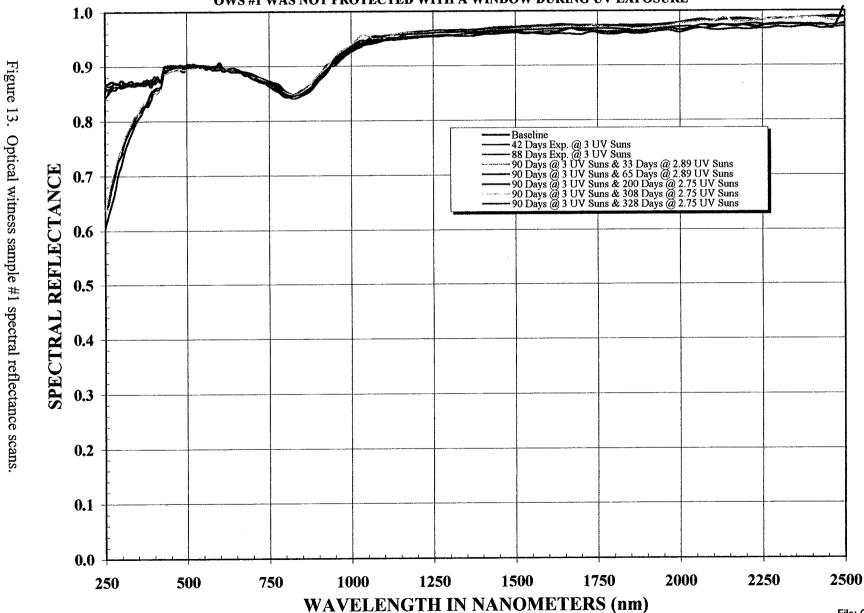
OPTICAL WITNESS SAMPLE #1 - LPSR DATA

BASELINE VS. 418 DAYS OF UV EXPOSURE, ALPHA=0.093 BEFORE AND 0.098 AFTER EXPOSURE OWS #1 WAS NOT PROTECTED WITH A WINDOW DURING UV EXPOSURE

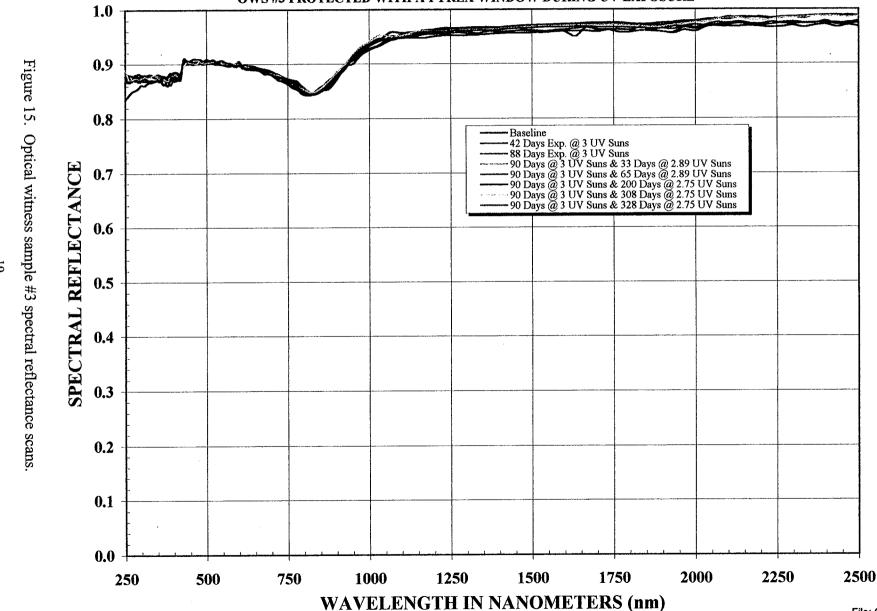
OPTICAL WITNESS SAMPLE #3 - LPSR DATA

BASELINE VS 418 DAYS OF UV EXPOSURE, ALPHA=0.094 BEFORE VS 0.089 AFTER EXPOSURE OWS #3 PROTECTED WITH A PYREX WINDOW DURING UV EXPOSURE

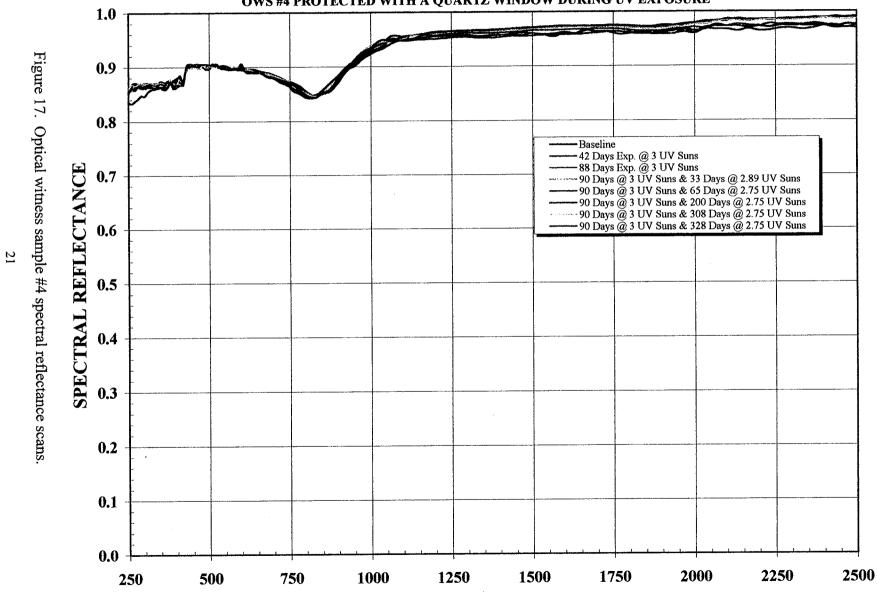
OPTICAL WITNESS SAMPLE #4 - LPSR DATA

BASELINE VS 418 DAYS OF UV EXPOSURE, ALPHA=0.093 BEFORE VS 0.091 AFTER EXPOSURE OWS #4 PROTECTED WITH A QUARTZ WINDOW DURING UV EXPOSURE

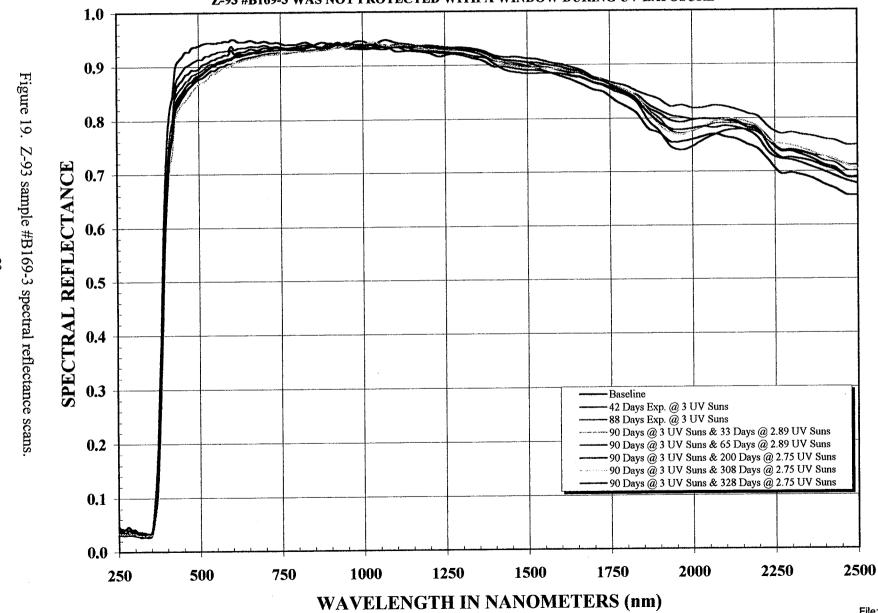
Z-93 WHITE DIFFUSE PAINT SAMPLE #B169-3 - LPSR DATA

BASELINE VS 418 DAYS OF UV EXPOSURE, ALPHA=0.157 BEFORE VS 0.175 AFTER EXPOSURE Z-93 #B169-3 WAS NOT PROTECTED WITH A WINDOW DURING UV EXPOSURE

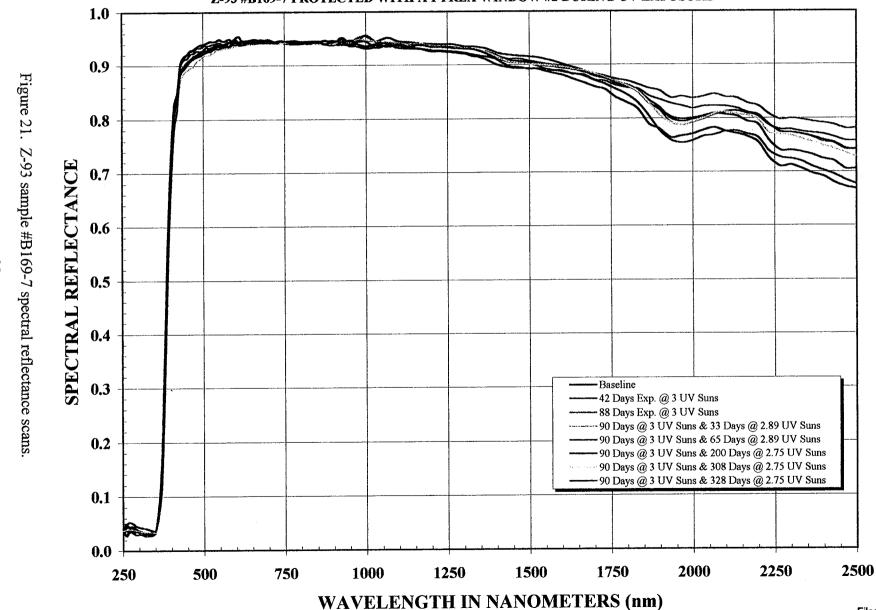
Z-93 WHITE DIFFUSE PAINT SAMPLE #B169-7 - LPSR DATA

BASELINE VS 418 DAYS OF UV EXPOSURE, ALPHA=0.155 BEFORE VS 0.160 AFTER EXPOSURE Z-93 #B169-7 PROTECTED WITH A PYREX WINDOW #2 DURING UV EXPOSURE

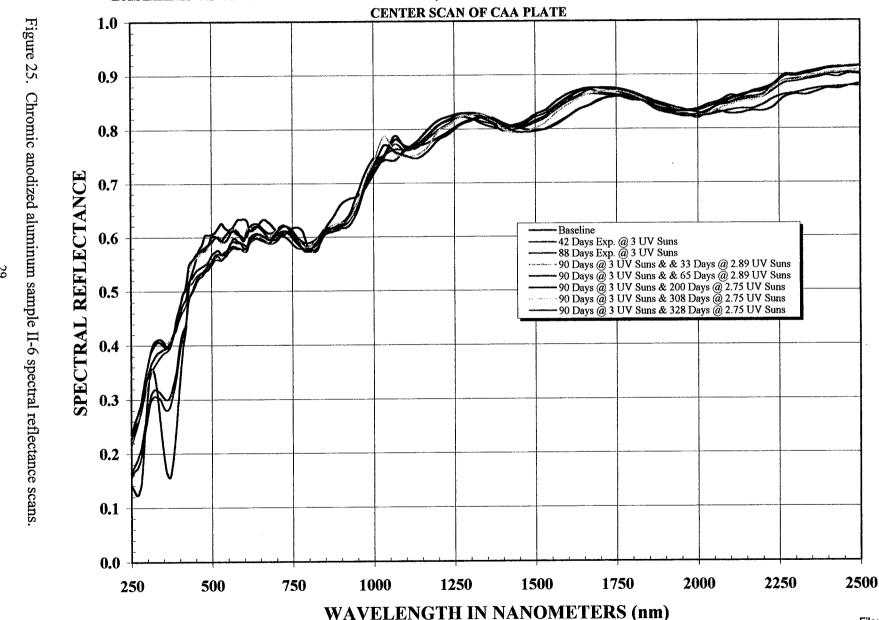
CHROMIC ANODIZED ALUMINUM SAMPLE II-6

BASELINE VS 418 DAYS OF UV EXPOSURE, ALPHA=0.364 BEFORE VS 0.354 AFTER EXPOSURE

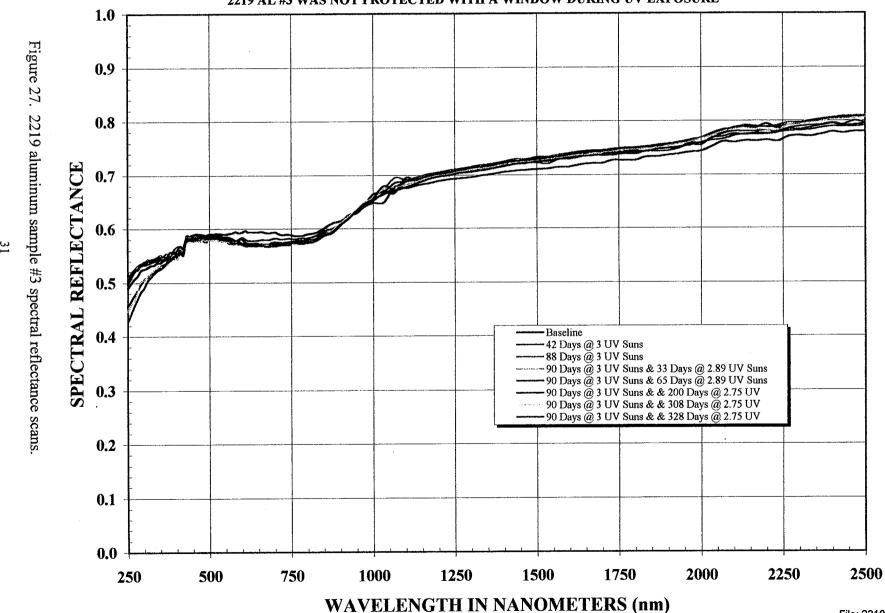
2219 ALUMINUM SAMPLE #3

BASELINE VS 418 DAYS OF UV EXPOSURE, ALPHA=0.375 BEFORE VS 0.379 AFTER EXPOSURE 2219 AL #3 WAS NOT PROTECTED WITH A WINDOW DURING UV EXPOSURE

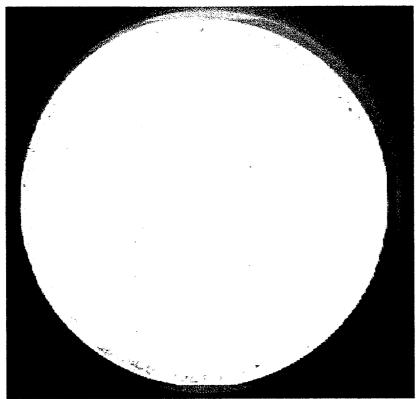
Figure 51. Unprotected optical witness sample #1.

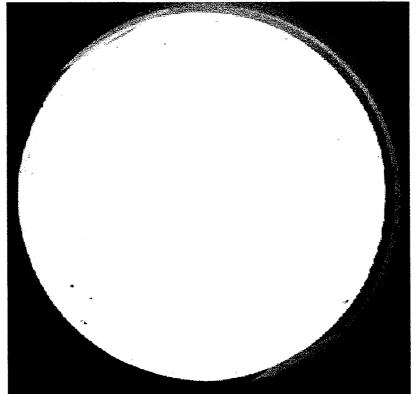
Figure 52. Optical witness sample #3protercted by Pyrex window #1.

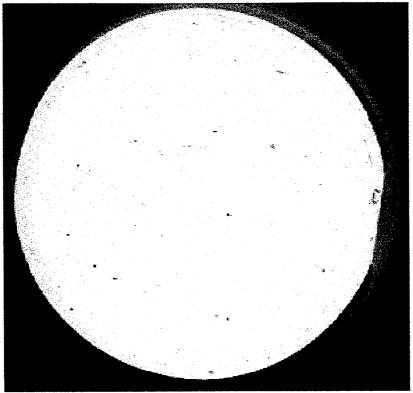
The fused silica window #1 protected optical witness sample #4 during NUV exposure. No changes were found in the LPSR scans until January 19,1996, after 290 days of exposure. On this scan we can see a drastic decrease in the spectral reflectance beginning at 550 nanometers. At 250 nanometers the spectral reflectance dropped from 0.85 to 0.73, a 14% decrease. Then the spectral reflectance dropped again on June 16 from 0.73 to 0.67, another 8% drop. Slight increases, around 1% between each scan, in the spectral reflectance occurred in the 1250 to 2500 nanometer range until the final scan on June 17, 1996 when the spectral reflectance dropped across the whole spectrum. But these slight variations in the spectral reflectance can be accounted for in the accuracy on the LPSR, being only ±1%. Solar alpha jumped from 0.11 on May 8th to 0.13 on June 17th. And an overall increase, when comparing the baseline to the final scan, from 0.10 to 0.13.

Figure 53. Optical witness sample #4 protected by fused silica window #1.

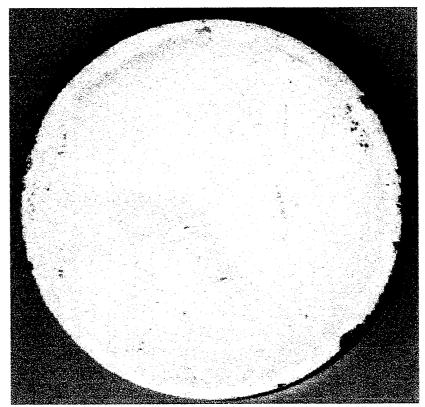
Z-93 sample #B169-3 was not protected during the NUV exposure study. The spectral reflectance decreased with each run in the 425 to 750 nanometer range. The most drastic decrease occurred between the baseline and the first scan on February 16th. An interesting thing to note is that the reflectance went back up slightly on the last run taken on June 17th. There were slight decreases in the spectral reflectance between each scan in the 1750 to 2500 nanometer range. When looking at the solar alpha, alpha continued to rise until the last scan on June 17th where it dropped from 0.182 to 0.175. The overall alpha changed from 0.157 on the baseline scan to 0.175 on the June 17th scan, the last scan performed.

Figure 54. Unprotected Z93 #B169-3 sample.

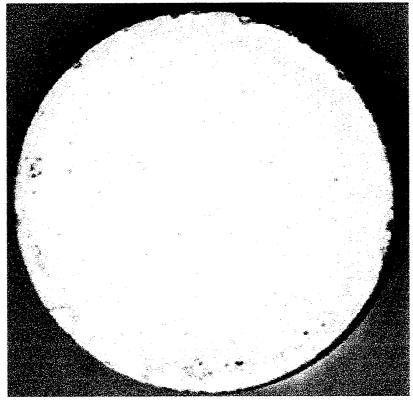
Figure 55. Z93 #B169-7 sample protected by Pyrex window #2.

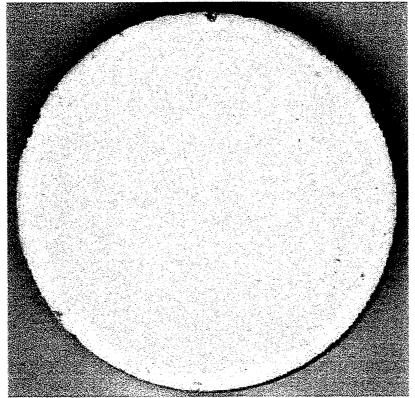
Z-93 sample #B169-13, which was protected with fused silica window #2, scans were similar to sample #B169-3. There was a decrease between each scan in both the 425 to 750 nanometer range and the 1750 to 2500 nanometer range. The solar alpha behaved slightly different in that there was not a rise in alpha on the final run on June 17th. Alpha increased throughout the entire run, beginning at 0.157 for the baseline and ending at 0.183 for the final scan.

Figure 56. Z93 #B169-13 protected by fused silica window #2.

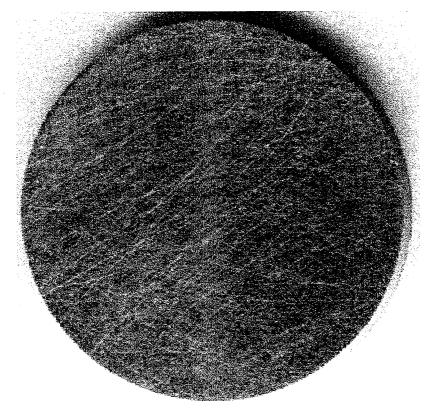
Figure 58. Unprotected 2219 aluminum sample #4.

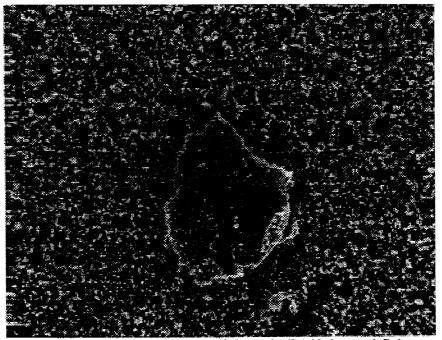
Figure 61. SEM photo of one of the Z-93 B169-3 metal flakes.

The first item we will discuss is the fact that the Z-93 series #B169 samples were prepared in a non-clean room facility. On inspection of the samples under a microscope small pieces of fiber and flakes of metal fragments appeared on the surface of the paint and imbedded in the paint itself. These items were most likely adhered to the surface when the white diffuse paint was sprayed onto the samples. The question is if this caused the discoloration of the sample and the changes in the reflectance, why did it take so long to appear. This is still not known at this time and needs further investigation until we can exactly pin point if this truly was the cause of the changes in the samples. The second issue to address is the method used for taking the LPSR measurements. During this procedure there are a number of unknowns that could be introduced into the system. Although we are extremely cautious, there are factors to consider. When the samples are removed from the chamber, the following procedure is used.

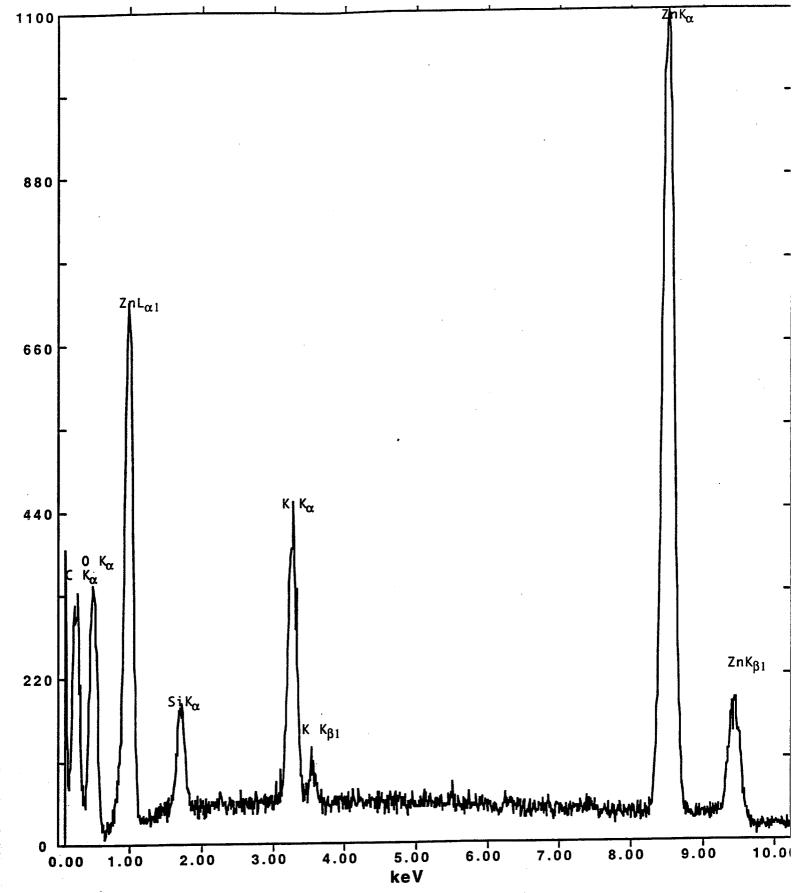
were found embedded in the paint. Therefore this needs to be considered when we talk about causes of the darkening effect found on the Z-93 samples. Two scanning electron micrographs were taken at 500X of two of the sample anomalies on the Z-93 samples, including one of the fibers and one of the metal flakes. Four micrographs were taken at 100X magnification of the metal fragments, fiber and fuzz found imbedded in the Z-93 B169-3 and B169-1 samples. These anomalies were found in all Z-93 B169 samples including the control sample. The SEM images, photoelectron spectra and micrographs of the flaws in the Z-93 paint samples are on pages 58-65, figures 60-69.

Figure 62. Photoelectron spectra of Z-93 #B169-3 imbedded fiber.

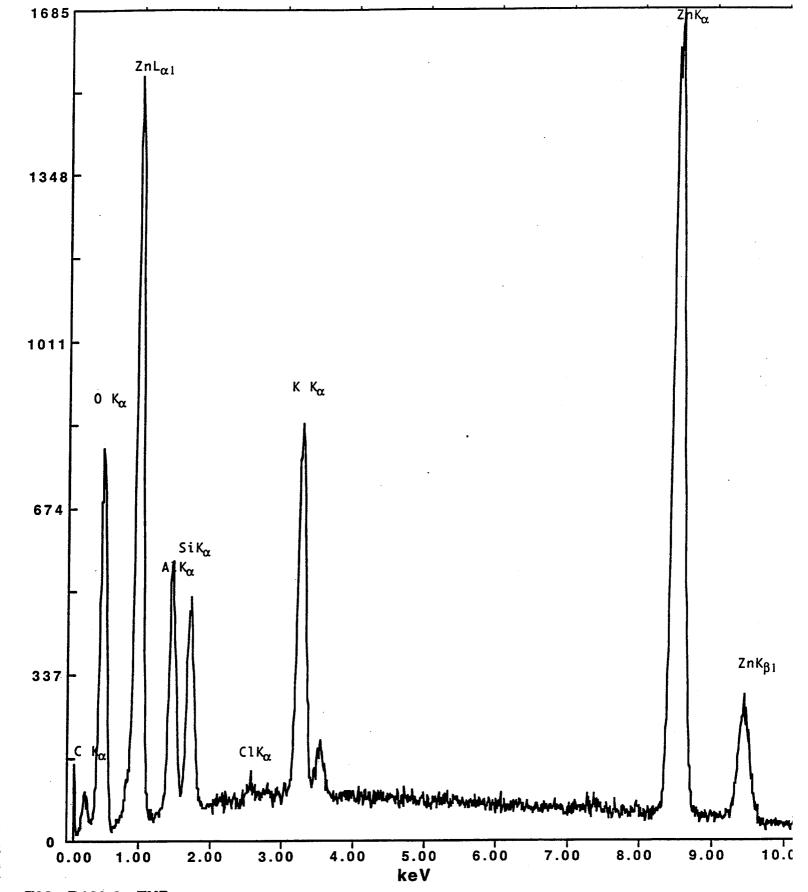
Figure 63. Photoelectron spectra of \mathbb{Z} -93 #B169-3 imbedded particle.

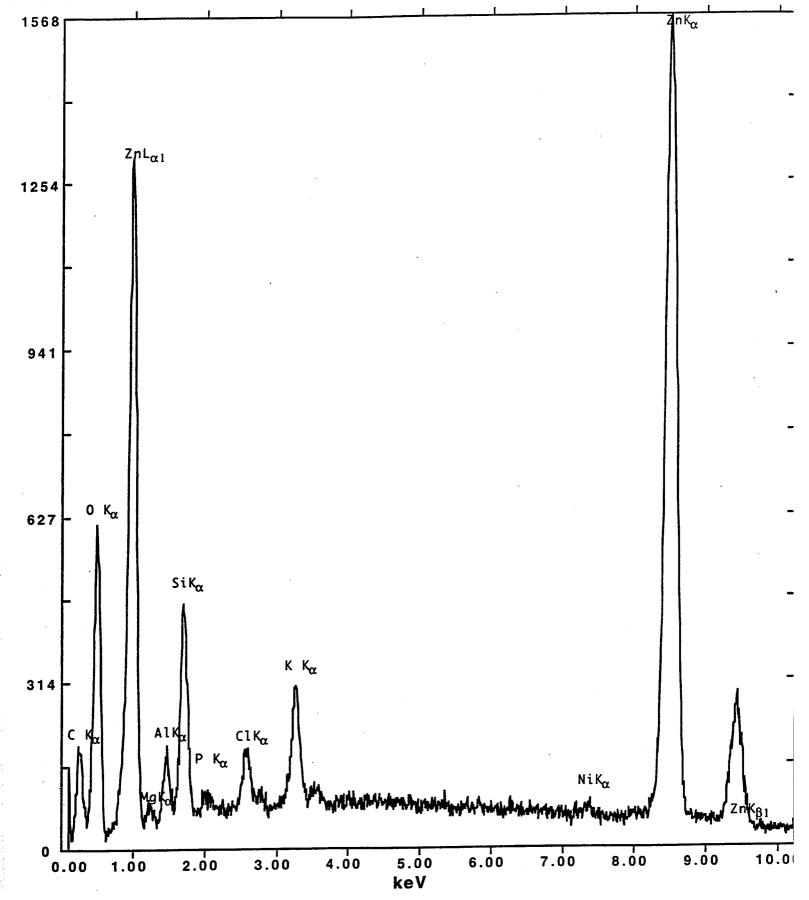
Figure 64. Photoelectron spectra of Z-93 #B169-3 imbedded metal flake.
